AIRWORTHINESS DIRECTIVE

Beechcraft 33 and 35-33 (Debonair/Bonanza) Series Aeroplanes

AD/BEECH 33/48
Amdt 1

Forward Elevator Cable

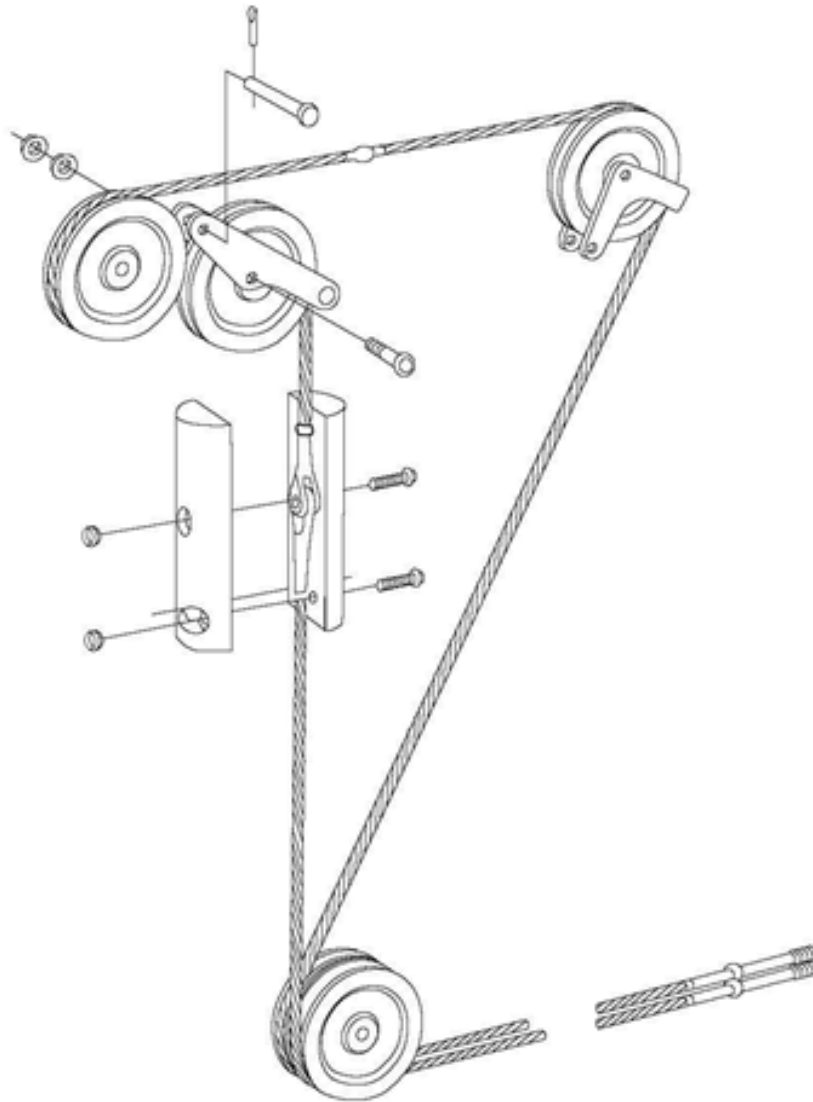
Figure 1 - Forward Elevator Control Cable - Adapted from Beechcraft Illustrated Parts Catalogue.

Applicability: All Beechcraft Debonair/Bonanza aeroplanes fitted with the forward elevator control cable configuration as detailed in figure 1 of this AD.

This Amendment clarifies the applicability section of the AD by introducing additional criteria (Figure 1) to assist the registered operator in determining whether this AD is applicable to their aircraft.

1. Inspect the forward elevator control cable assembly for wear, broken wires and corrosion; or replace the forward elevator cable assembly.
2. Remove from service any forward elevator control cable assembly found to be defective as a result of inspection conducted in accordance with Requirement 1 of this AD.
3. Do not install on any aircraft a cable assembly or parts thereof that have been removed in accordance with Requirement 2 of this AD.
