[Docket No. FAA-2010-1013; Directorate Identifier 2010-CE-048-AD; Amendment 39-16478; AD 2010-21-18]

Airworthiness Directives; Cessna Aircraft Company (Cessna) Models 336, 337, 337A (USAF 02B), 337B, M337B (USAF 02A), T337B, 337C, T337C, 337D, T337D, 337E, T337E, 337F, T337F, 337G, T337G, 337H, P337H, T337H, T337H-SP, F337E, FT337E, F337F, FT337F, F337G, FT337GP, F337H, and FT337HP Airplanes

2010-21-18 Cessna Aircraft Company: Amendment 39-16478; Docket No. FAA-2010-1013; Directorate Identifier 2010-CE-048-AD.

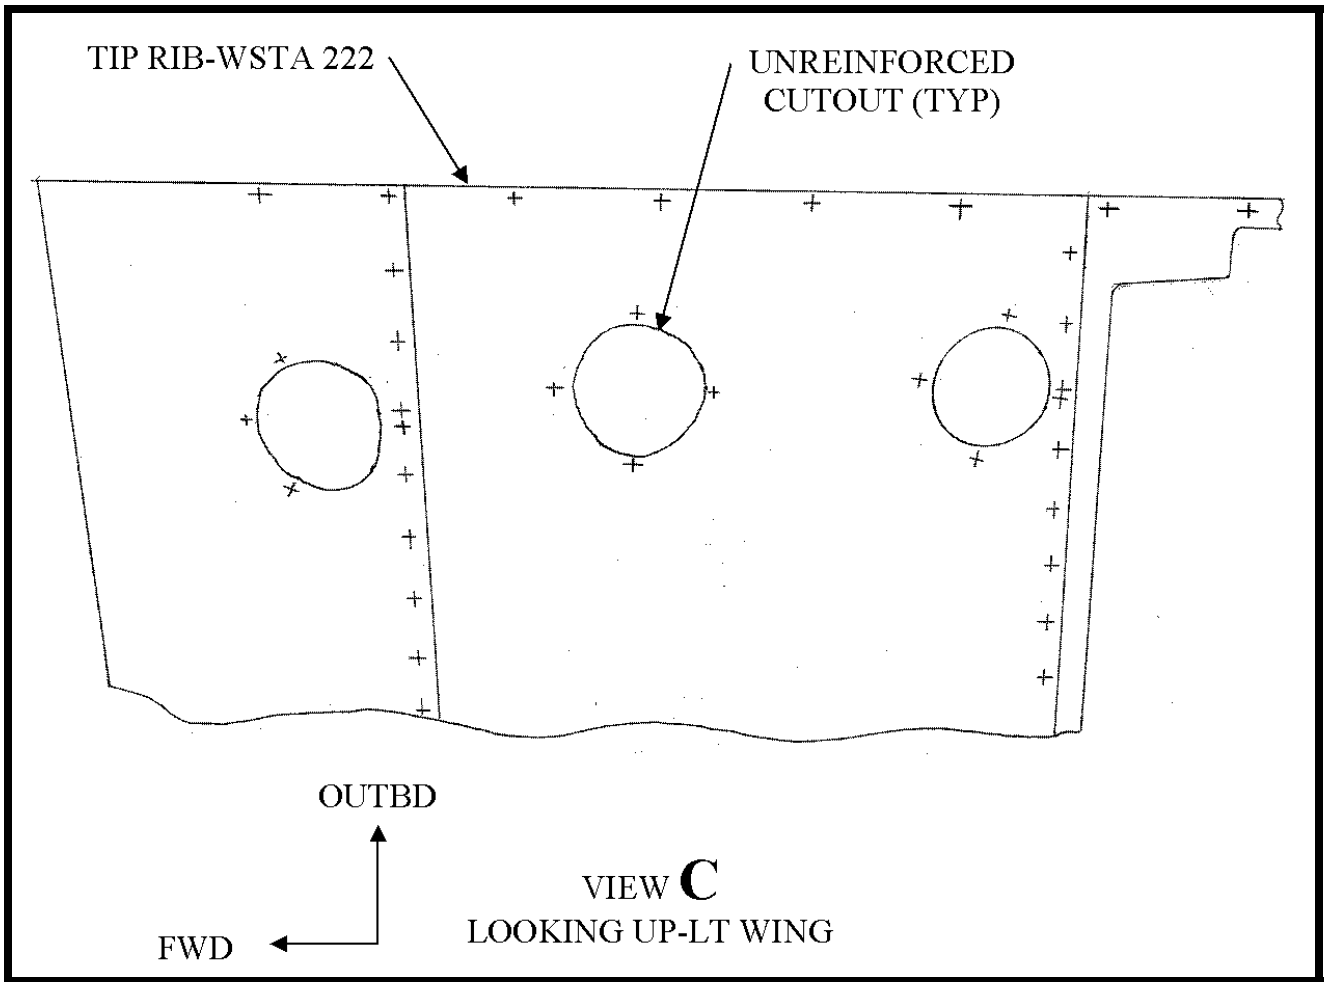
Figure 4

- (2) Inspect wing skins for unreinforced cutouts. (See View C, Figure 4).
- (3) Inspect the upper spar cap horizontal flanges for open holes (See View D, Figure 5).
