**[Docket No. FAA-2011-0450; Directorate Identifier 2011-CE-010-AD; Amendment 39-16758; AD 2011-15-11]**

**Airworthiness Directives; Cessna Aircraft Company (Cessna) Models 337, 337A (USAF 02B), 337B, 337C, 337D, 337E, T337E, 337F, T337F, 337G, T337G, M337B, F 337E, FT337E, F 337F, FT337F, F 337G, and FT337GP Airplanes**

**2011-15-11 Cessna Aircraft Company:** Amendment 39-16758; Docket No. FAA-2011-0450; Directorate Identifier 2011-CE-010-AD.

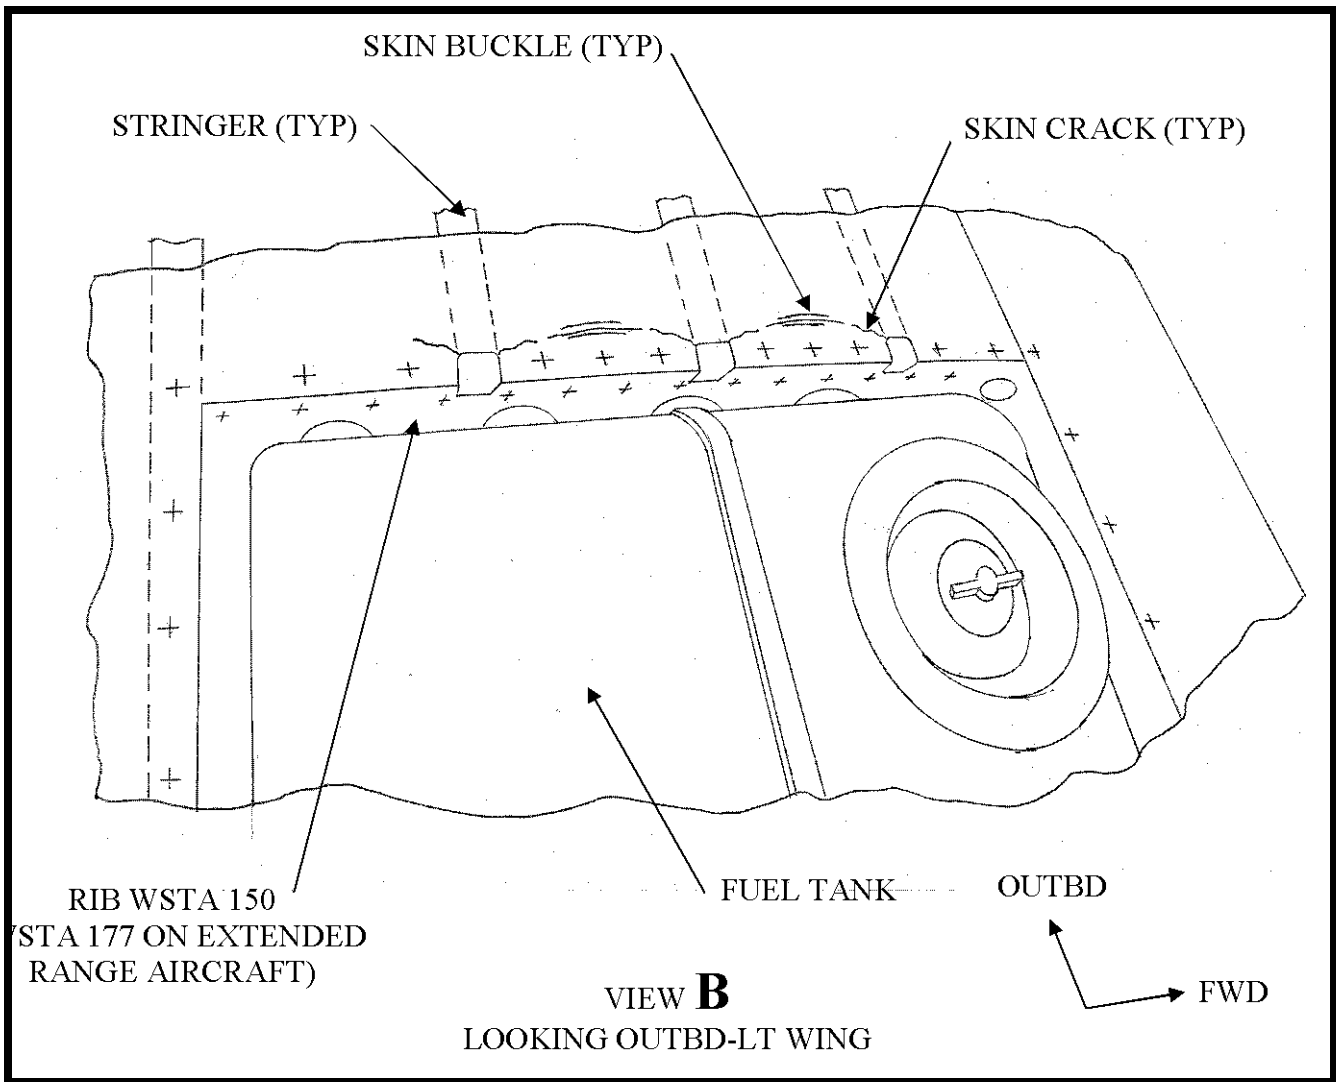
**Figure 3**

- (1) Wrinkles in upper wing skins, from the outboard edge on the fuel tank access covers (WSTA 150 or 177) to the WSTA 222 (See View B, Figure 3).
- (2) Wrinkles in the upper wing skins from WSTA 55 to 66, adjacent to the booms (See View E, Figure 6).

- (3) Cracking of the upper wing skins. Pay particular attention to any wrinkles, the radius between stiffeners at WSTA 150 (under fuel tank covers), and unreinforced access holes (See View B, Figure 3).
