Grob G115 Series Aeroplanes

AIRWORTHINESS DIRECTIVE

AD/GROB 115/12
Amdt 1

Elevator Trim Tab

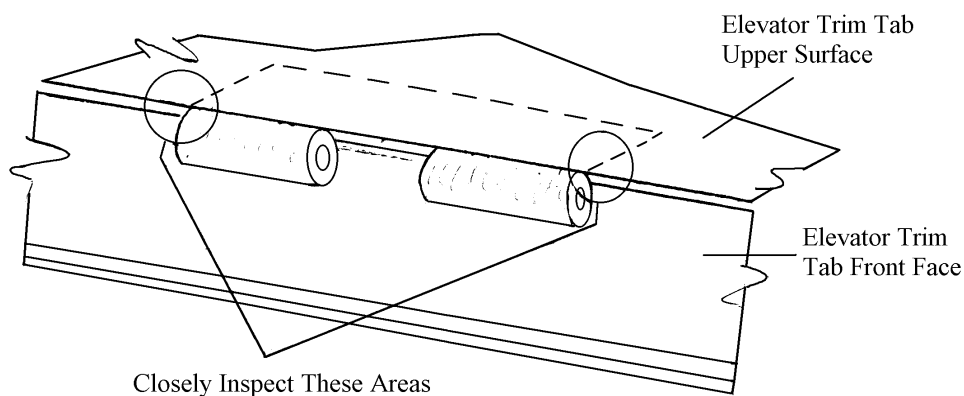
Figure 1
Elevator Trim Tab Hinge
Typical

Inspect using a x 10 magnifying glass around all Elevator Trim Tab hinges for cracking or debonding between the hinge tabs and the resin (See Figure 1). Not only the upper surface of the tab is to be examined, but close attention is to be paid to the junction between the sides/lower surface of the hinge flap and the forward edge of the elevator trim tab.

Note 2: The flap segment of the hinge attached to the trim tab runs under the upper surface of the tab.

Note 3: The debonding of the hinges appears as 'cracking' along the line joining the resin and hinge tabs. The growth rate of any cracking will be extremely fast. Further, the crack progression will not be uniform nor similar to fatigue cracking. Therefore, any cracking found is indicative that the entire hinge has debonded.

Background: On return from a flight a trim tab was found nearly departed from an aircraft. Investigations found that the cause was bond failure between the hinges and the attaching resin. A further 6 tabs have since been found debonded, with one of the tabs having little more than 50 hrs TTIS. A loose trim tab can lead to flutter of the control surface. The manufacturer has been advised, and the initial issue of this AD was an interim solution pending development of a permanent solution.
