Partenavia P68 Series Aeroplanes

AD/P68/46

Engine Cowl

2/2000 TX

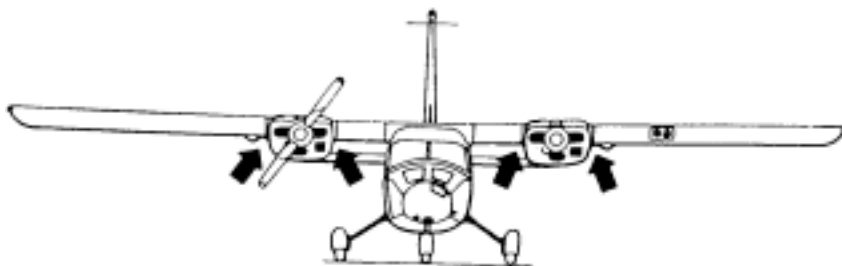
FIGURE 1 LOCATIONS TO BE INSPECTED

Ensure that the most forward fastener of the 'pop' fasteners attaching each engine cowl rear side fairings to the under surface of the wing is in line with the solid rivets of the lower spar cap. To assist with locating the areas, refer to the attached diagrams. If all four subject fasteners are in line with the spar cap rivets, then no further action is required.

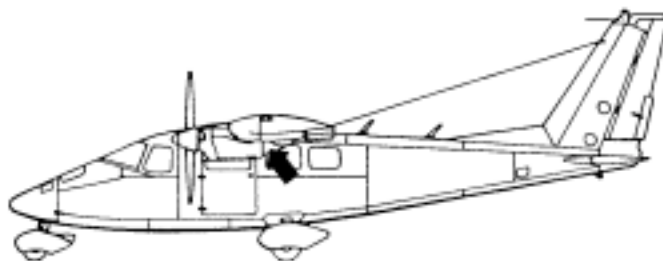
FIGURE 2 - SIDE VIEW HIGHLIGHTING AFFECTED AREA

Background: An aircraft has been found with an engine cowl fastener incorrectly installed into the main spar. The fastener, instead of attaching the cowl fairing to the wing spar horizontal flange, was incorrectly driven into the body of the mainspar, thus compromising the fatigue properties of the spar. As a result of this incorrect locating of the fairing, the second most forward fastener has impacted the rear edge of the lower spar cap flange.

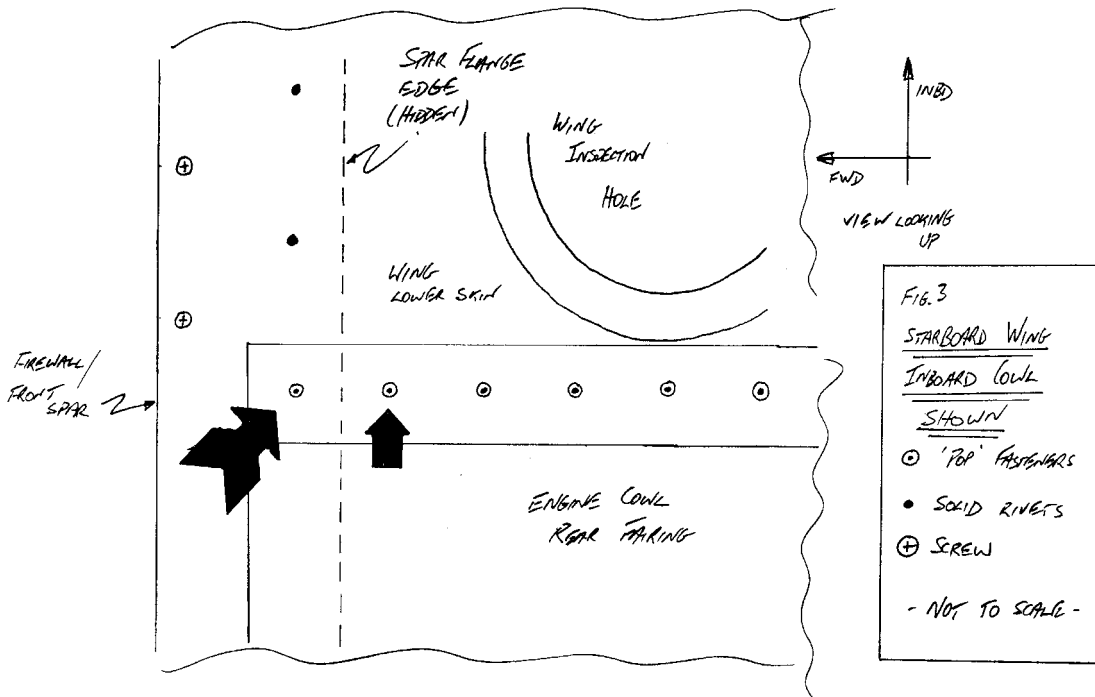
➡ CHECK LOCATION OF THIS 'POP' FASTENER RELATIVE TO LINE OF SOLID RIVETS OF LOWER SPAR CAP.
 NOTE: CORRECT ALIGNMENT SHOWN

➡ CHECK LOCATION OF THIS 'POP' FASTENER RELATIVE TO SPAR FLANGE IF FORWARD 'POP' FASTENER MISALIGNED.

If a fastener is not in line with the spar cap rivets, before further flight, the location of the forward fastener, its orientation and direction relative to the all spar cap elements is to be determined. The second most forward fastener is also to be inspected in a similar manner.

In all cases of misaligned fasteners, a defect report is to be made to CASA and an assessment by a CAR 35 authorised person is required prior to further flight.
