[Docket No. FAA-2014-1083; Directorate Identifier 2014-CE-036-AD; Amendment 39-18140; AD 2015-08-04]

Airworthiness Directives; Various Aircraft Equipped With Wing Lift Struts

ACTION: Final rule.

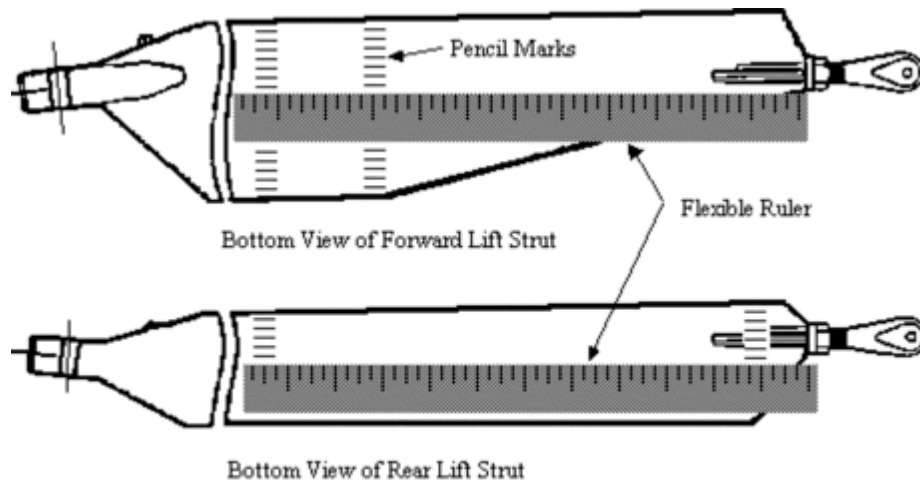
Figure 1

8. A measurement of 0.024-inch or less shall require replacement of the strut prior to further flight.

9. If at any time during testing an area is encountered where a valid thickness measurement cannot be obtained due to a loss of signal strength or quality, the area shall be considered suspect. These areas may have a remaining wall thickness of less than 0.020-inch, which is below the range of this setup, or they may have small areas of localized corrosion or pitting present. The latter case will result in a reduction in signal strength due to the sound being scattered from the rough surface and may result in a signal that includes echoes from the pits as well as the backwall. The suspect area(s) shall be tested with a Maule "Fabric Tester" as specified in Piper MSB No. 528D, dated October 19, 1990, or Piper MSB No. 910A, dated October 10, 1989.
