Piper PA-24 (Comanche) Series Aeroplanes

**AD/PA-24/41
Amdt 2**

Wing Inspection for Fatigue Cracking

PIPER
Airworthiness Directive
Final Copy of Letter
Volume I

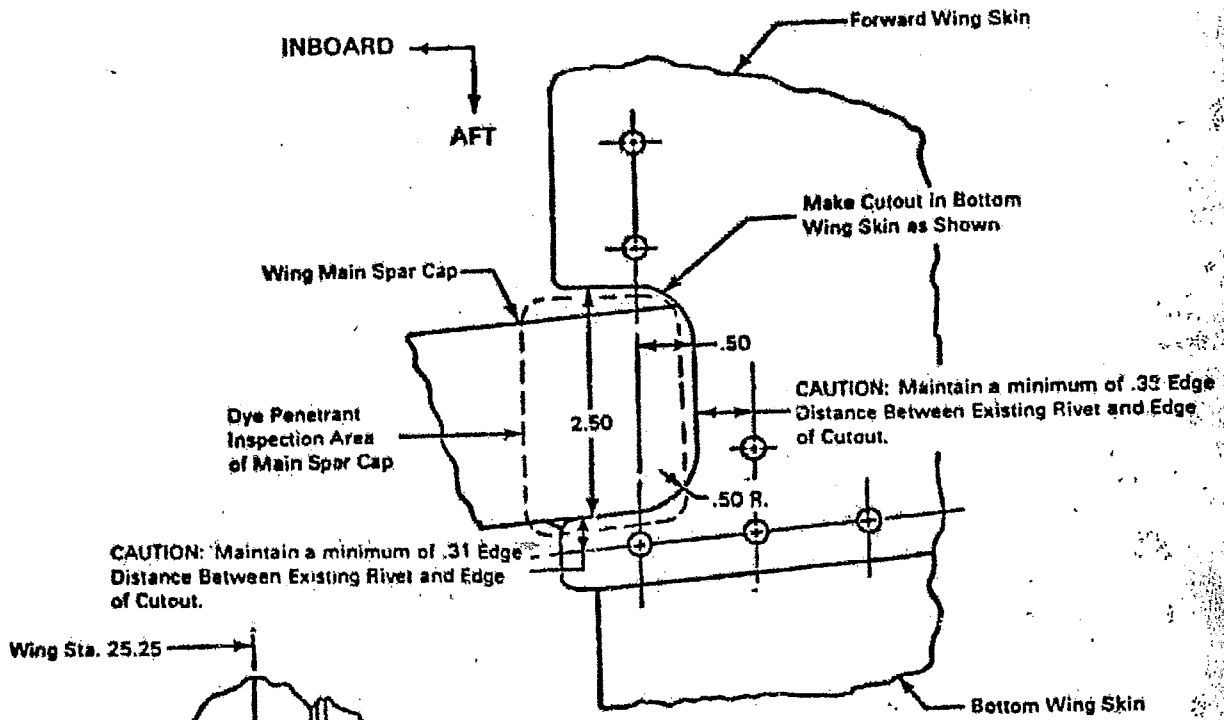
FIGURE 1

3. Per Figure 1, outline wing skin area to be removed. Assure a minimum edge distance as shown between existing rivets and edge of cut out.

5. Cut out wing skin in area as shown on Figure 1 and dress all edges smooth.

6. Using a suitable stripper, remove the paint and thoroughly clean the bottom spar cap in area shown on Figure 1.

Exercise caution to avoid scratching or damaging the spar surface. Using dye penetrant method, inspect bottom spar cap in the designated area for cracks. (Refer to Figure 1.)

B. Add a fabricated plate made of .040 (2024T3 Aluminum) to the wing fairing using standard AN rivets to cover wing skin cut out area per Figure 1; overlap adjoining wing skin approximately 1/2 inch. Ensure attachment rivets do not protrude in line with spar cap or wing skin.

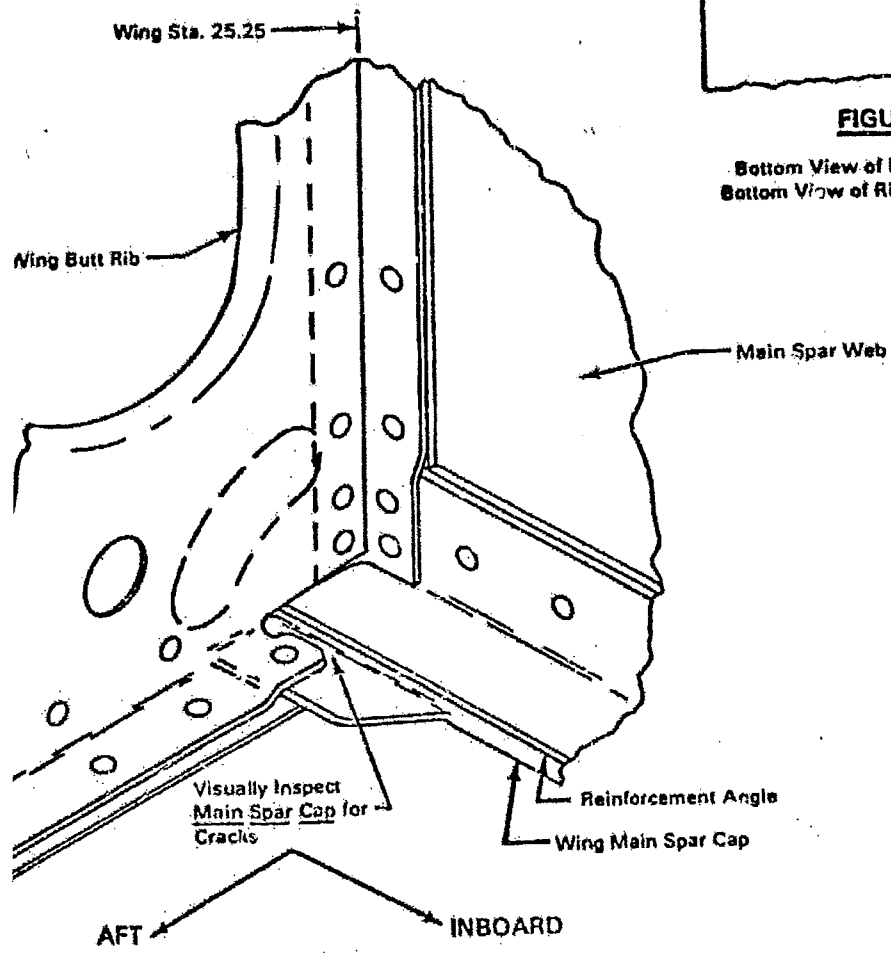
FIGURE 2

7. Using a light and mirror, visually inspect for cracks on the bottom spar cap aft flange per Figure 2.

d) Before further flight, replace cracked parts with undamaged parts of the same part number, or accomplish a repair which is approved by the Manager, New York Aircraft Certification Office, FAA, New England Region.
