AIRWORTHINESS DIRECTIVE

Piper PA-24 (Comanche) Series Aeroplanes

**AD/PA-24/44
Amdt 1**

Main Landing Gear Side Brace Stud

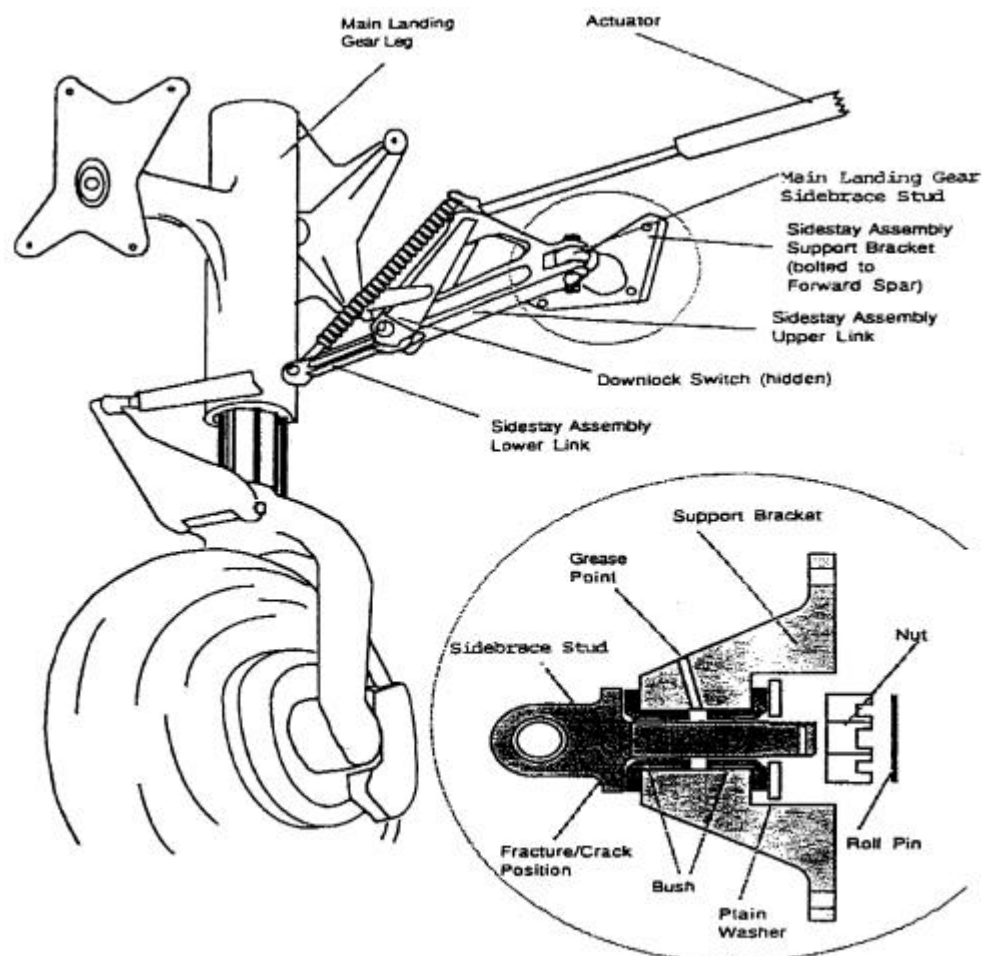
Requirement: Remove both the left and right main gear side brace studs from the aircraft in accordance with the instructions contained in the Landing Gear section of the maintenance manual, and inspect each main gear side brace stud for cracks using fluorescent penetrant or magnetic particle inspection methods. Figure 1 of this Directive depicts the area where the sidebrace stud is to be inspected.

This figure is provided to depict the area of the sidebrace stud to be inspected. This is not intended to represent the configuration of all models affected.

Background: The FAA received reports of main gear side brace stud cracks, including seven incidents where the main landing gear collapsed. The actions specified by this Directive are intended to prevent a main gear collapse caused by main gear side brace stud cracks, which could result in loss of control of the aircraft during landing operations.

For any main gear side brace stud found cracked, replace the cracked stud with an approved serviceable part in accordance with the instructions contained in the Landing Gear section of the applicable maintenance manual.
