AIRWORTHINESS DIRECTIVE

Piper PA-25 (Pawnee) Series Aeroplanes

**AD/PA-25/17
Amdt 5**

Fuselage Structure - Corrosion

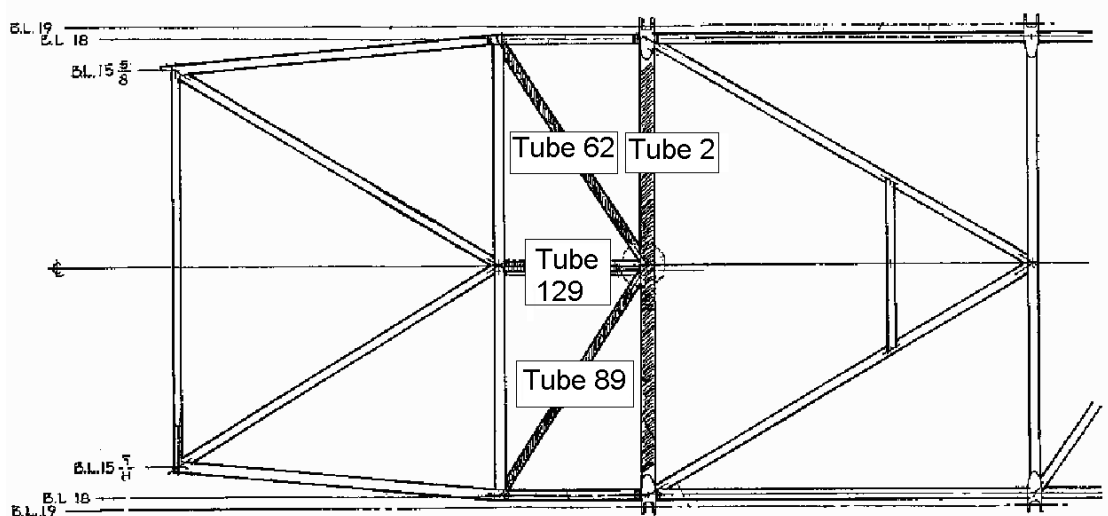
PA-25
source: Piper drawing 61001

- Requirement: 1. Radiographically inspect the following tubes in the fuselage for internal corrosion:
- (a) PA-25 tubes numbers 62, 89, 2 and 129 shown in Piper drawing 61001.

Compliance: For para. 1(a) - Within 5 years from date of manufacture and thereafter at intervals not exceeding 6 years.

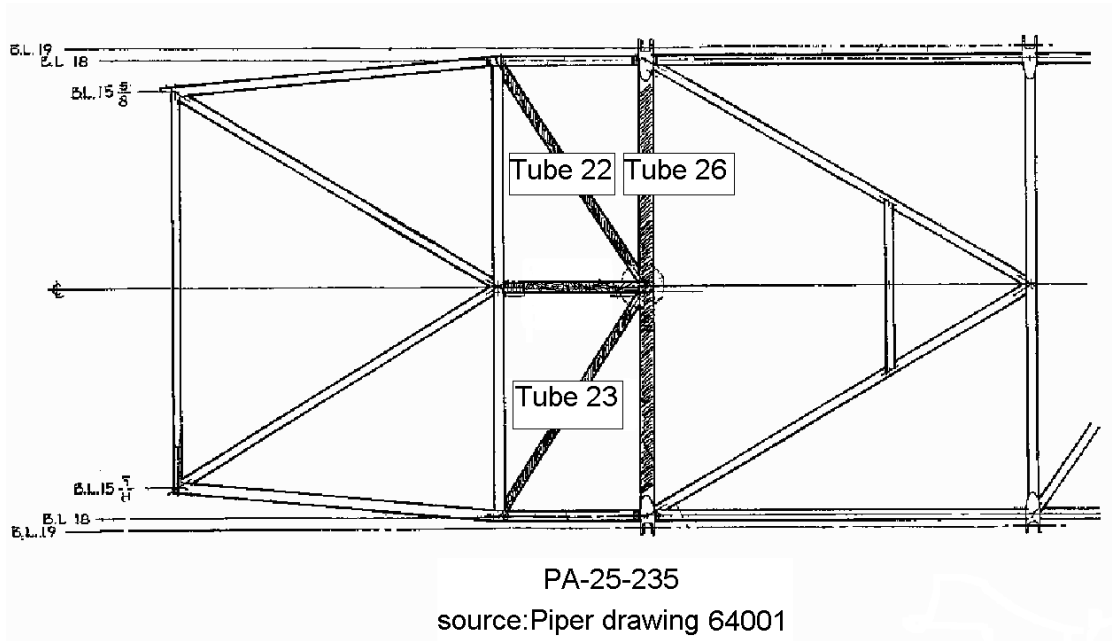
- (b) PA-25-235 and 260 tube numbers 22, 23 and 26 shown in Piper drawing 64001.

For para. 1(b) - Within 5 years from date of manufacture or repair.
