### Piper PA-28 Series Aeroplanes

**AD/PA-28/91  
Amdt 1**

### Main Landing Gear Side Brace Stud

**9/2002**

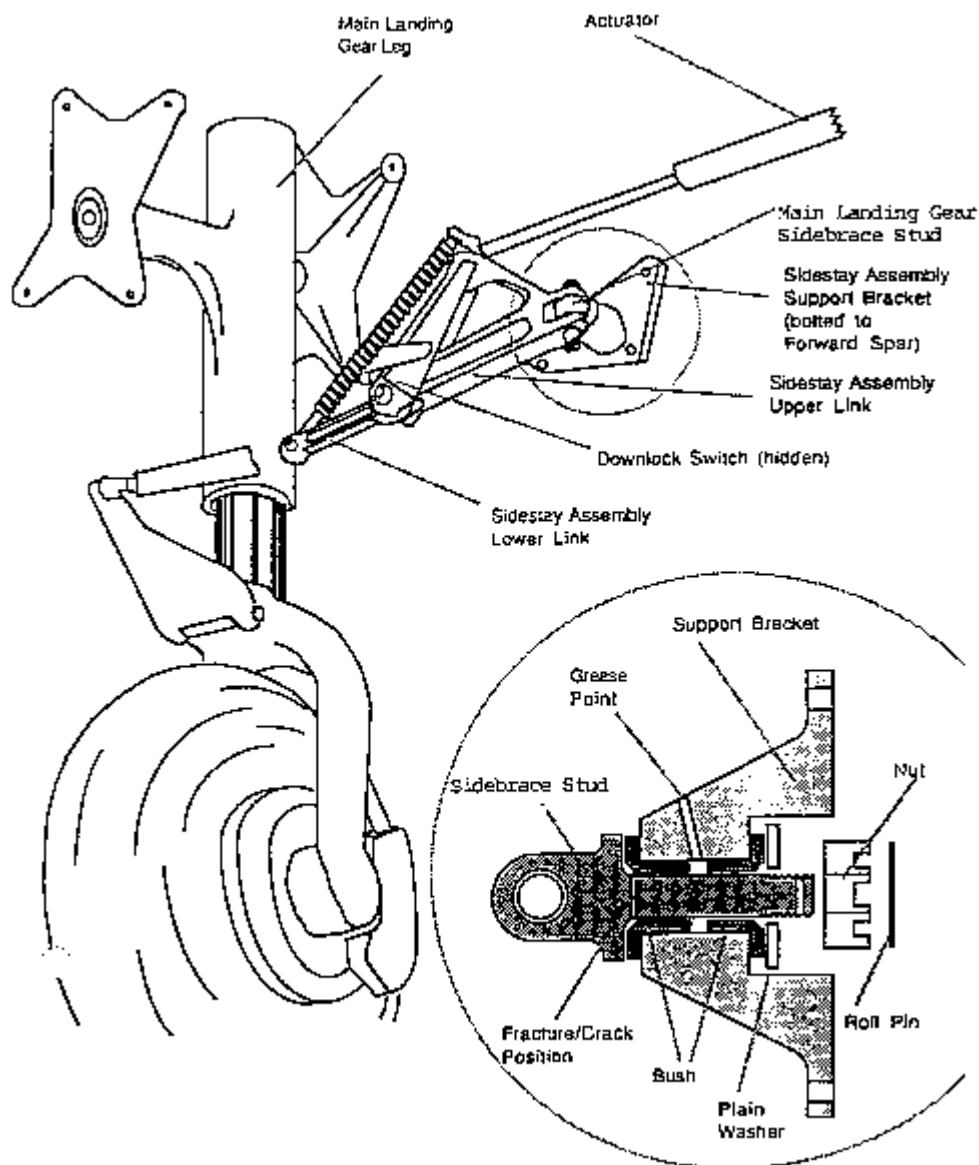
**Requirement:** Remove both the left and right main gear side brace studs from the aircraft in accordance with the instructions contained in the Landing Gear section of the maintenance manual, and inspect each main gear side brace stud for cracks using fluorescent penetrant or magnetic particle inspection methods. Figure 1 of this Directive depicts the area where the sidebrace stud is to be inspected.

This figure is provided to depict the area of the sidebrace stud to be inspected. This is not intended to represent the configuration of all models affected.

Background: The FAA received reports of main gear side brace stud cracks, and seven associated incidents where the main landing gear collapsed. The actions specified by this Directive are intended to prevent a main gear collapse caused by main gear side brace stud cracks, which could result in loss of control of the aircraft during landing operations.

For any main gear side brace stud found cracked, replace the cracked stud with an approved serviceable part in accordance with the instructions contained in the Landing Gear section of the applicable maintenance manual.

For the affected Models PA28R-180, -200, -201, and -201T aircraft, the part number 95299-00 or 95299-02 main gear side brace studs are no longer manufactured. A new main gear side brace stud bracket assembly, part number(s) 95643-06, 95643-07, 95643-08, or 95643-09, as applicable, must be installed if cracks are found as a result of the required inspection. No repetitive inspection will be required for these affected aircraft models when this bracket assembly is installed;

For the affected Model PA-28R-180, PA-28R-200, PA-28R-201, and PA-28R-201T aircraft, ream the existing two-piece bushings to an inside diameter of 0.624 inch to 0.625 inch, chamfer the head side of the bushing to accommodate the radius in the shank of the main gear side brace stud, and install the 5/8 inch stud, P/N 78717-02. No repetitive inspections will be required by this Airworthiness Directive when this action is accomplished on both the left and right bracket assemblies. If the bushings cannot be reamed while installed in the bracket (i.e., the bushings are loose), then install a main gear side brace bracket assembly, P/N 95643-06, P/N 95643-07, P/N 95643-08, or P/N 95643-09, as applicable. Models PA-28R-180 with serial numbers 28R-30004 through 28R-31270 and PA-28R-200 with serial numbers 28R-35001 through 28R-35820 and 28R-7135001 through 28R-7135062, may be equipped with a bracket casting identified with casting number 67073-2 or 67073-3 and may require the following modification to P/N 78717-02 for proper installation:

- a. Reduce the length of the stud to  $1.688 \pm 0.15$  inches;
- b. Add additional rolled threads to  $1.125 \pm 0.015$  inches from the flange. Note that the stud is heat treated to 180 to 200 ksi; and
- c. Drill an additional roll pin hole 90 degrees to the existing hole, and approximately 1.480 inches from the flange.
