## AIRWORTHINESS DIRECTIVE

### Piper PA-30 & 39 (Twin Comanche) Series Aeroplanes

**AD/PA-30/34  
Amdt 1**

### Main Landing Gear Side Brace Stud

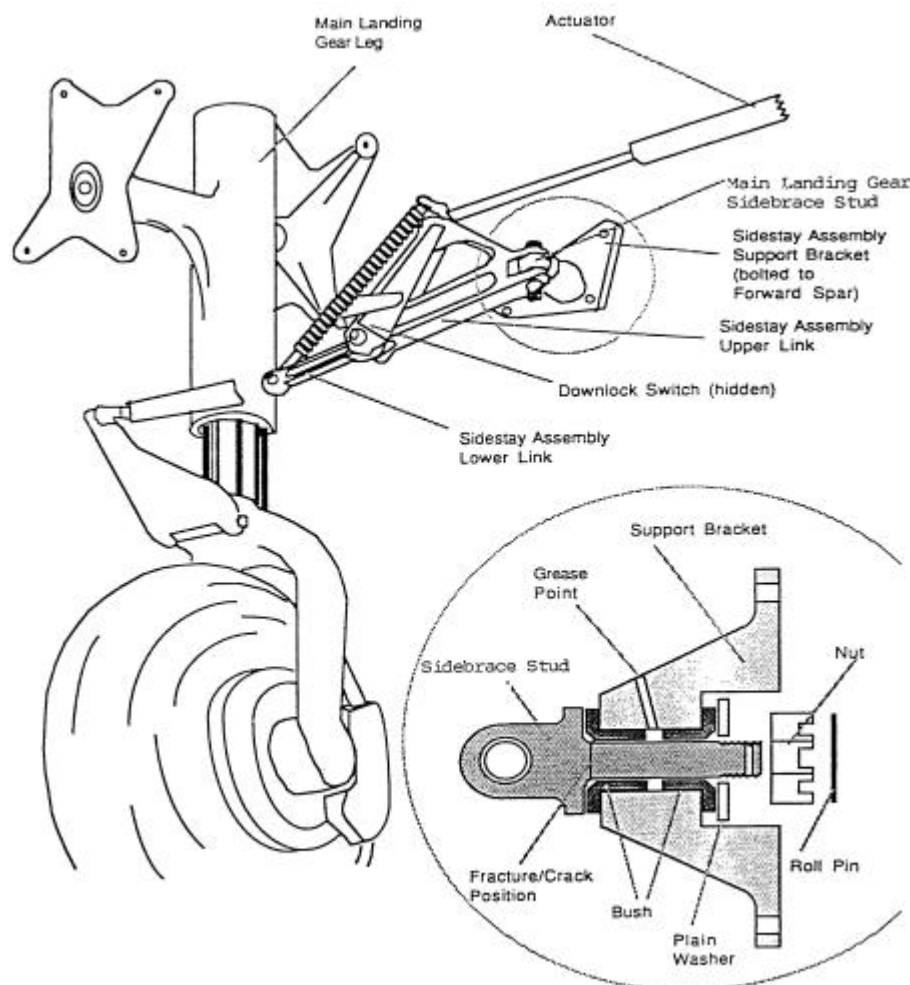
Requirement: Remove both the left and right main gear side brace studs from the aircraft in accordance with the instructions contained in the Landing Gear section of the maintenance manual, and inspect each main gear side brace stud for cracks using fluorescent penetrant or magnetic particle inspection methods. Figure 1 of this Directive depicts the area where the sidebrace stud is to be inspected.

**Background:** The FAA received reports of main gear side brace stud cracks, including seven incidents where the main landing gear collapsed. The actions specified by this Directive are intended to prevent a main gear collapse caused by main gear side brace stud cracks, which could result in loss of control of the aircraft during landing operations.

For any main gear side brace stud found cracked, replace the cracked stud with an approved serviceable part in accordance with the instructions contained in the Landing Gear section of the applicable maintenance manual.
