Piper PA-32 (Cherokee Six) Series Aeroplanes

**AD/PA-32/63**                      **Turbocharger Exhaust System - Inspection**                      **7/79**

Applicability:    Model PA-32RT-300T with S/Nos. 32R-7887001 to 32R-7987126.

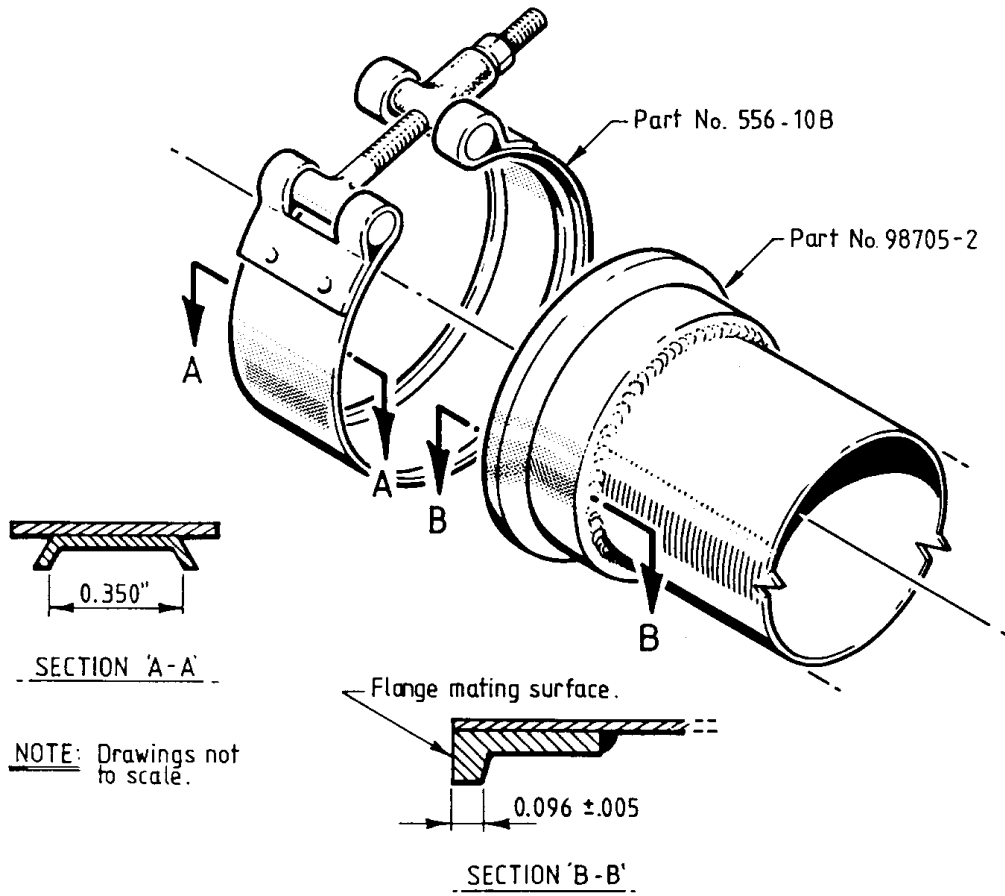
FIG. 1.

- Requirement:    1. Remove turbocharger exhaust coupling P/N 556108 and tailpipe P/N 98705-2.
2. Using either a dye penetrant method or a 10X lens, inspect coupling, coupling bolt, tailpipe and tailpipe flange for cracks, deformation and damage.
3. Measure width across inside opening of coupling retainer segments. Maximum allowable dimension is 0.350 inches (See Figure 1.).
4. Measure thickness of tailpipe flange at apex. Dimension required is 0.096 inches plus or minus 0.005 inches (See Figure 1.).
5. If flange dimension is under the tolerance shown in (4) above, replace tailpipe. If over tolerance, rework the flange mating surface to dimensions in (4) above, provided 0.005 inches flatness is maintained, or replace with serviceable part.
6. Replace any exhaust system part found cracked, deformed or damaged.

Background:    The FAA reports failures of the turbocharger exhaust system due to cracking and deformation. Leakage of hot gases in this area will cause a fire hazard.

*Note: During installation of serviceable parts ensure turbocharger and tailpipe flanges are properly aligned. Tap coupling gently to distribute band tension while tightening coupling nut. Torque coupling nut to 40-50 inch pounds and lockwire.*
