## AIRWORTHINESS DIRECTIVE

### Piper PA-32 (Cherokee Six) Series Aeroplanes

**AD/PA-32/79**  
**Amdt 1**

**Main Landing Gear Side Brace Stud**

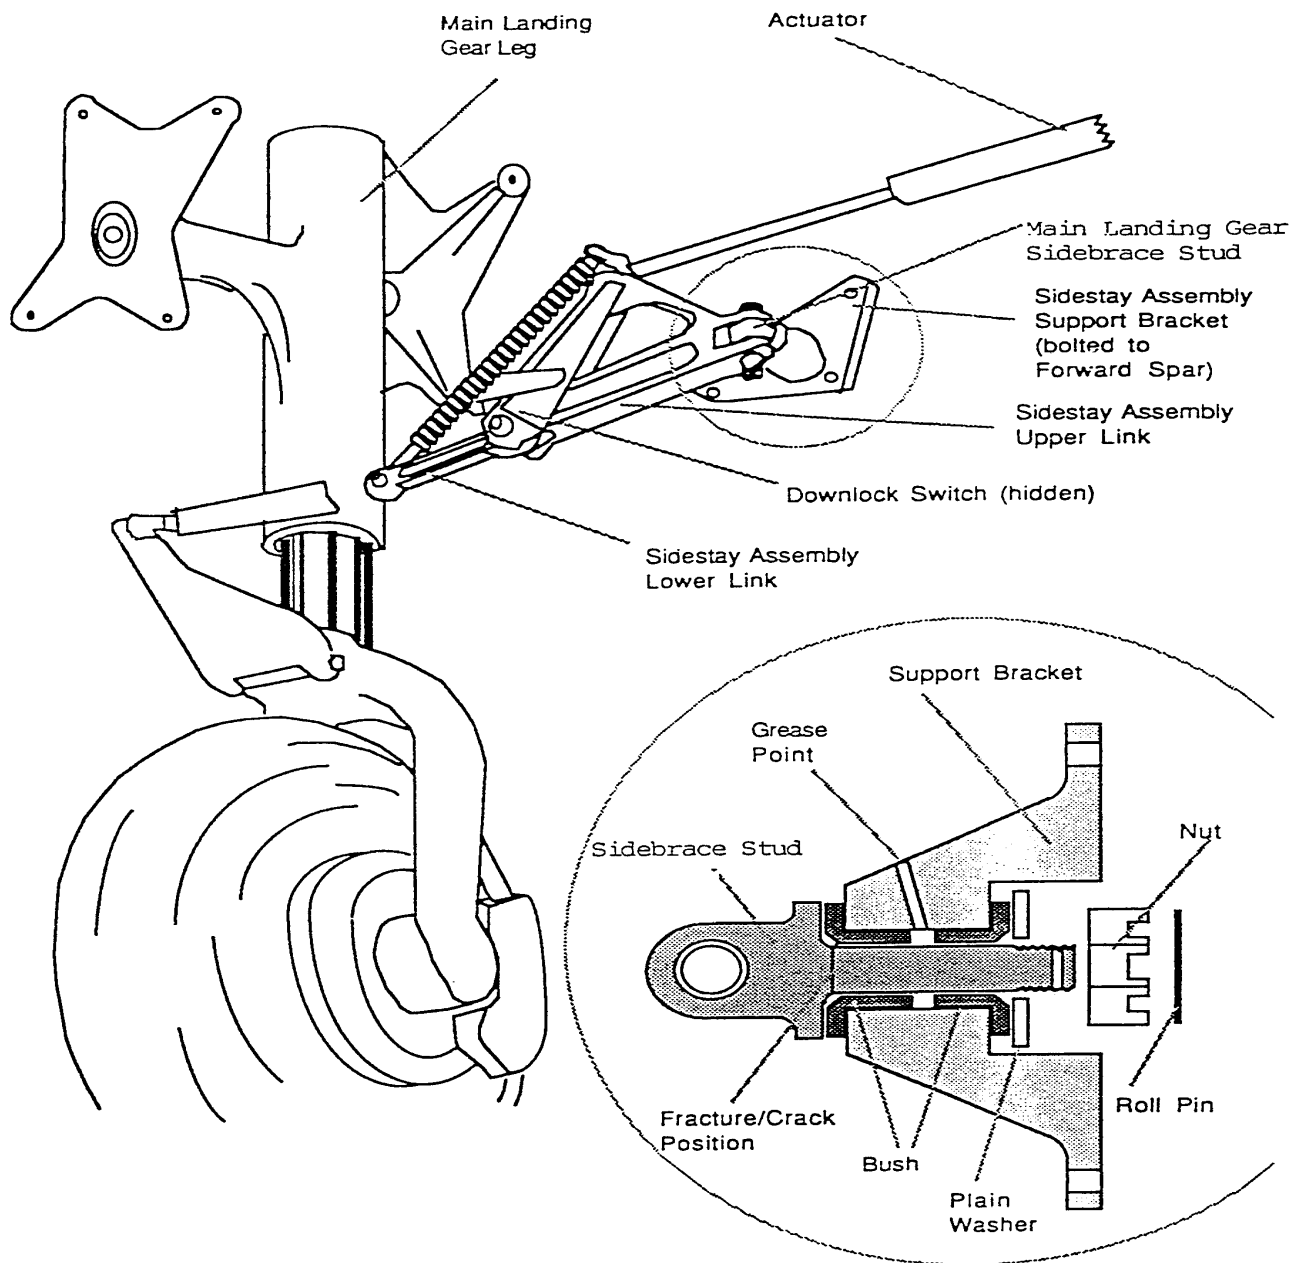
**Requirement:** Remove both the left and right main gear side brace studs from the aircraft in accordance with the instructions contained in the Landing Gear section of the maintenance manual, and inspect each main gear side brace stud for cracks using fluorescent penetrant or magnetic particle inspection methods. Figure 1 of this Directive depicts the area where the sidebrace stud is to be inspected.

This figure is provided to depict the area of the sidebrace stud to be inspected. This is not intended to represent the configuration of all models affected.

Background: The FAA received reports of main gear side brace stud cracks, and seven associated incidents where the main landing gear collapsed. The actions specified by this Directive are intended to prevent a main gear collapse caused by main gear side brace stud cracks, which could result in loss of control of the aircraft during landing operations.

For any main gear side brace stud found cracked, replace the cracked stud with an approved serviceable part in accordance with the instructions contained in the Landing Gear section of the applicable maintenance manual.

For the affected Model PA32R-300 aircraft, the part number 95299-00 or 95299-02 main gear side brace studs are no longer manufactured. A new main gear side brace stud bracket assembly, part number(s) 95643-06, 95643-07, 95643-08, or 95643-09, as applicable, must be installed if cracks are found as a result of the required inspection. No repetitive inspection will be required for these affected aircraft models when this bracket assembly is installed;

For the affected Model PA32R-300 aircraft, ream the existing two-piece bushings to an inside diameter of 0.624 inch to 0.625 inch, chamfer the head side of the bushing to accommodate the radius in the shank of the main gear side brace stud, and install the 5/8 inch stud, P/N 78717-02. No repetitive inspections will be required by this Airworthiness Directive when this action is accomplished on both the left and right bracket assemblies. If the bushings cannot be reamed while installed in the bracket (i.e., the bushings are loose), then install a main gear side brace bracket assembly, P/N 95643-06, P/N 95643-07, P/N 95643-08, or P/N 95643-09, as applicable.
