## AIRWORTHINESS DIRECTIVE

### Piper PA-34 (Seneca) Series Aeroplanes

**AD/PA-34/43  
Amdt 2**

**Nose Gear Upper Drag Link Bolt**

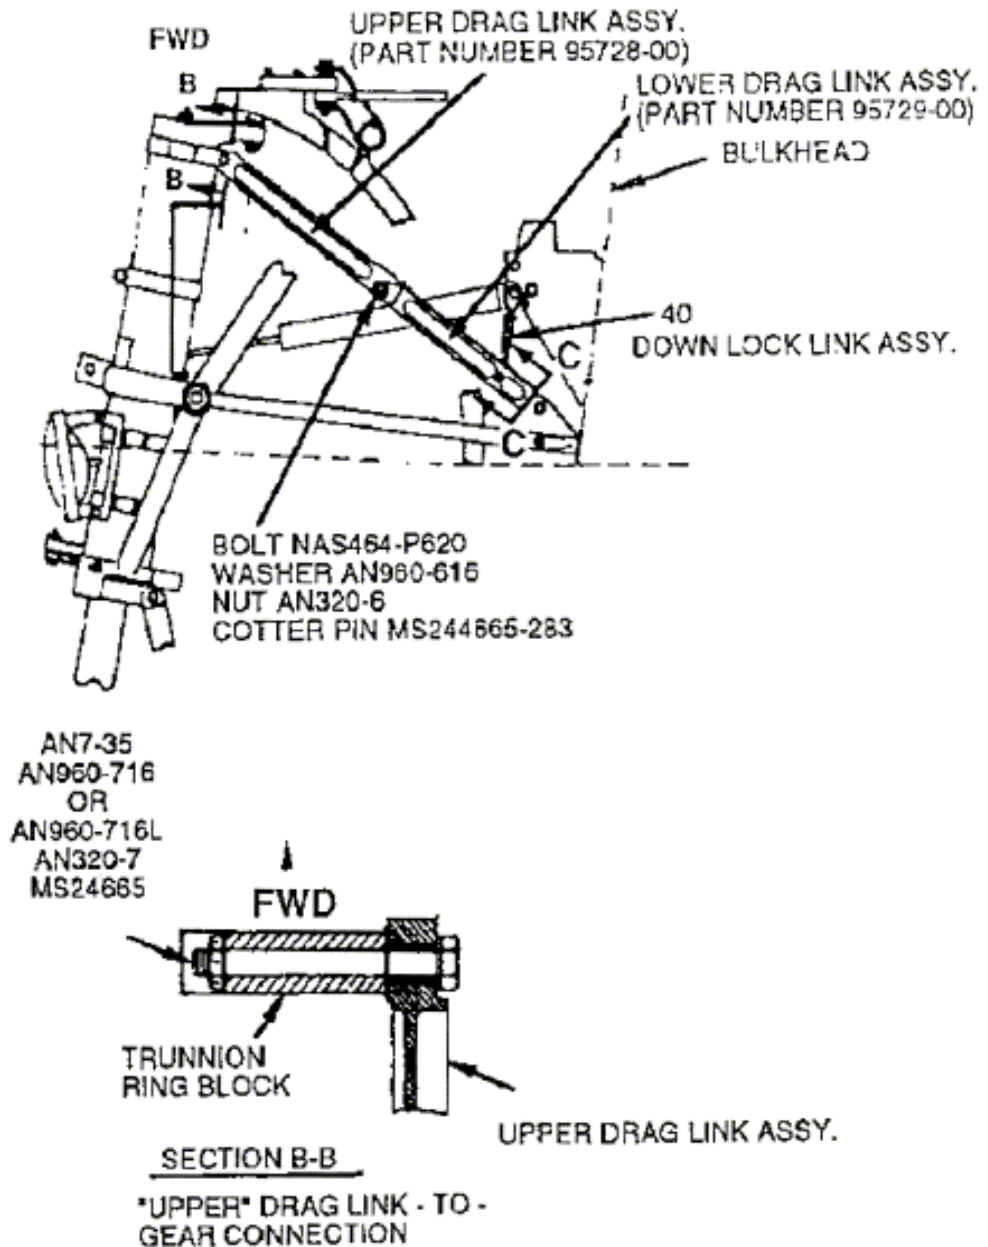
**Figure 1**

Background: This Airworthiness Directive is the result of service difficulty reports related to the collapse or involuntary retraction of the nose landing gear (NLG). The actions specified in this Airworthiness Directive are intended to detect, correct, and prevent failure in certain components of the NLG, lack of cleanliness of the NLG due to inadequate maintenance, or lack of lubricant in the NLG or NLG components. This failure of the NLG could lead to loss of control of the airplane during take-off, landing, or taxiing operations.

- Requirement:
1. Replace the bolt and attached parts that connect the upper drag link to the nose gear trunnion with the following new parts in accordance with Figure 1 of this Directive:
    - (a) Piper part number 400 274 (AN7-35) bolt.
    - (b) Piper part number 407 591 (AN960-716L) washer, as applicable.
    - (c) Piper part number 407 568 (AN960-716) washer, as applicable.
    - (d) Piper part number 404 396 (AN320-7) nut; and
    - (e) Piper part number 424 085 (MS24665) cotter pin.
  2. Carry out the inspections, replacements and other corrective actions specified in Table 1 "Scheduled Maintenance" of Piper Service Bulletin (SB) No. 1123B dated 20 April 2006 or later FAA approved revision.
  3. Do any necessary corrective actions as a result of the actions specified in Table 1 "Scheduled Maintenance" of Piper Service Bulletin No. 1123B or later FAA approved revision.
