AIRWORTHINESS DIRECTIVE

Piper PA-34 (Seneca) Series Aeroplanes

AD/PA-34/46
Amdt 1

Main Landing Gear Side Brace Stud

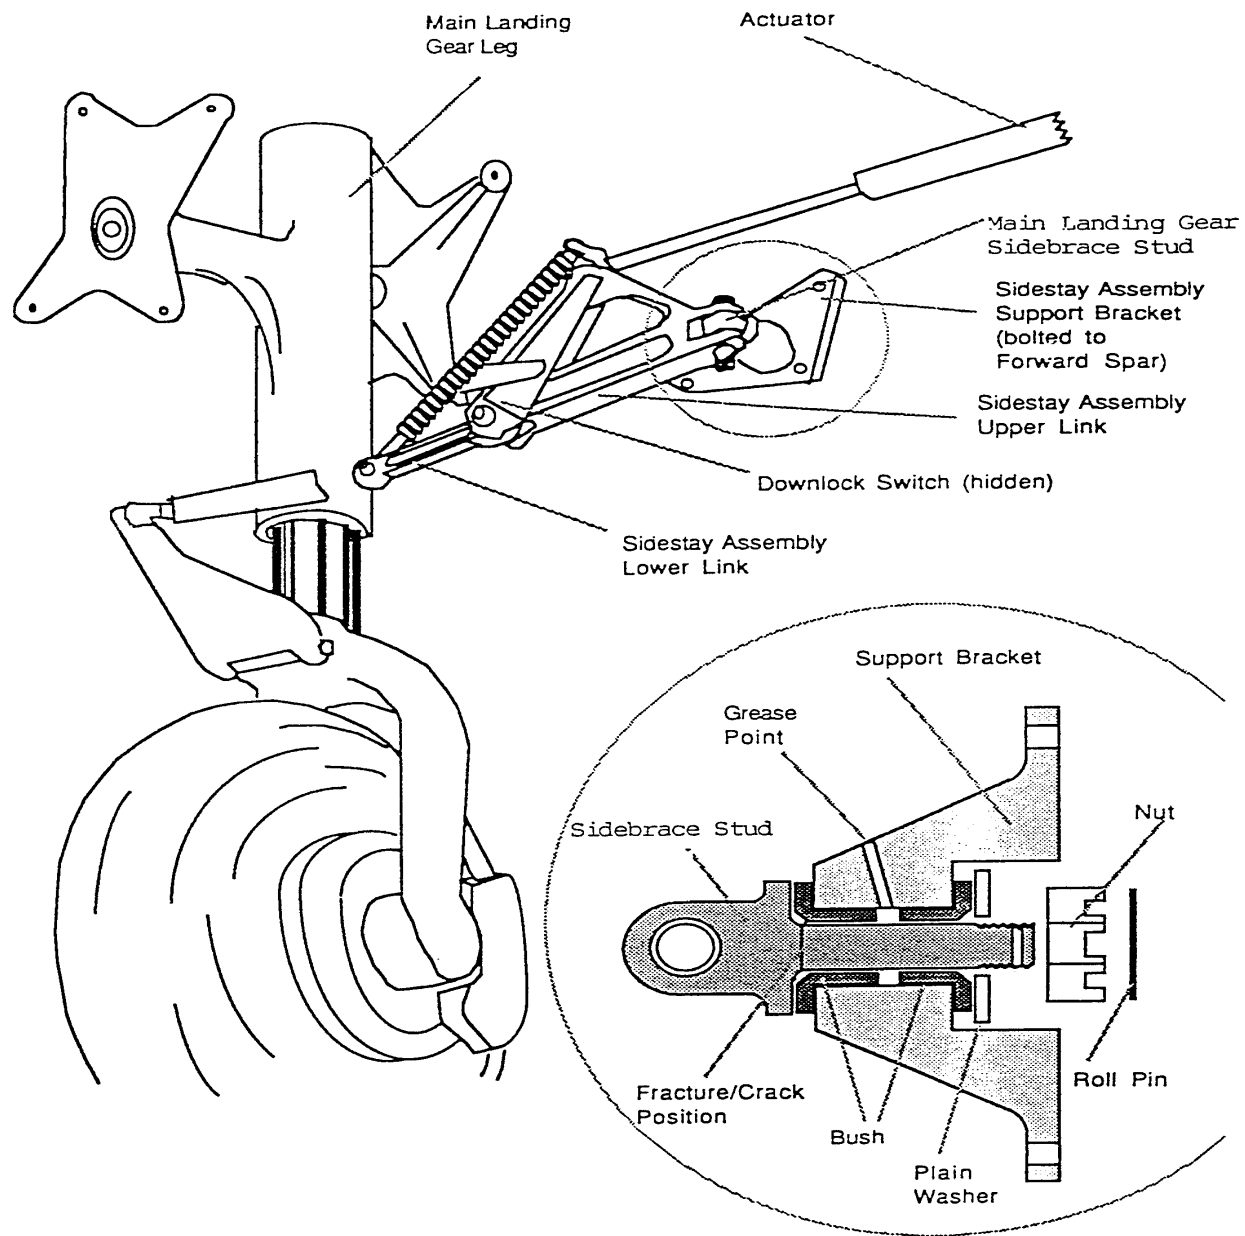
Requirement: Remove both the left and right main gear side brace studs from the aircraft in accordance with the instructions contained in the Landing Gear section of the maintenance manual, and inspect each main gear side brace stud for cracks using fluorescent penetrant or magnetic particle inspection methods. Figure 1 of this Directive depicts the area where the sidebrace stud is to be inspected.

This figure is provided to depict the area of the sidebrace stud to be inspected. This is not intended to represent the configuration of all models affected.

Background: The FAA received reports of main gear side brace stud cracks, and seven associated incidents where the main landing gear collapsed. The actions specified by this Directive are intended to prevent a main gear collapse caused by main gear side brace stud cracks, which could result in loss of control of the aircraft during landing operations.

For any main gear side brace stud found cracked, replace the cracked stud with an approved serviceable part in accordance with the instructions contained in the Landing Gear section of the applicable maintenance manual.

For the affected Model PA34-200 and PA34-200T aircraft, the part number 95299-00 or 95299-02 main gear side brace studs are no longer manufactured. A new main gear side brace stud bracket assembly, part number(s) 95643-06, 95643-07, 95643-08, or 95643-09, as applicable, must be installed if cracks are found as a result of the required inspection. No repetitive inspection will be required for these affected aircraft models when this bracket assembly is installed;

For the affected Model PA-34-200 and PA-34-200T aircraft, ream the existing two-piece bushings to an inside diameter of 0.624 inch to 0.625 inch, chamfer the head side of the bushing to accommodate the radius in the shank of the main gear side brace stud, and install the 5/8 inch stud, P/N 78717-02. No repetitive inspections will be required by this Airworthiness Directive when this action is accomplished on both the left and right bracket assemblies. If the bushings cannot be reamed while installed in the bracket (i.e., the bushings are loose), then install a main gear side brace bracket assembly, P/N 95643-06, P/N 95643-07, P/N 95643-08, or P/N 95643-09, as applicable.
