Victa and A.E.S.L. Airtourer Series Aeroplanes

AIRWORTHINESS DIRECTIVE

**AD/VAT/42
Amdt 1**

**Control Column Wagglers P/N 52115 -
Inspection and Modification**

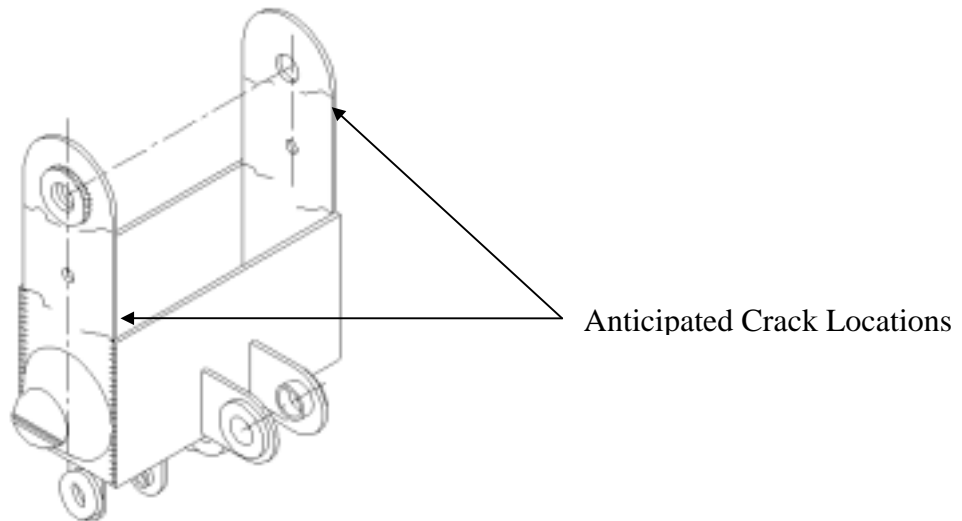
Figure 1

Requirement: 1. Visually inspect both Wagglers attach arms for cracks in accordance with Edge Aviation Service Bulletin EA-AT-2000/001 Issue 1 Section 2. Anticipated crack locations are as indicated at Figure 1.

Background: The original issue of this AD was raised as a result of two instances of control column waggler arm cracking having been found following aileron control malfunction. This amendment is issued as a result of a further case of a seriously cracked waggler, and also to update the AD and require modification of the wagglers rather than indefinite periodic inspections.

2. Modify in accordance with Edge Aviation Service Bulletin EA-AT-2000/001 Issue 1 Section 3 or a modification approved by a CAR 35 Authorised Person.

Note: Wagglers modified in accordance with the initial issue of this AD have waggler arms which have been doubled in thickness by the addition of welded doublers to the outer faces of the side attachment arms. Total thickness of the side attachment arms of modified wagglers should be approximately 0.098" (2.49mm). Wagglers so modified meet requirement 2 of this AD.
