AIRWORTHINESS DIRECTIVE

Eagle X-TS Series Aeroplanes**AD/X-TS/5
Amdt 2****Flap Hinge Support Bracket****5/2006**

Applicability: All Model X-TS, X-TS 150 and 150B Aircraft.

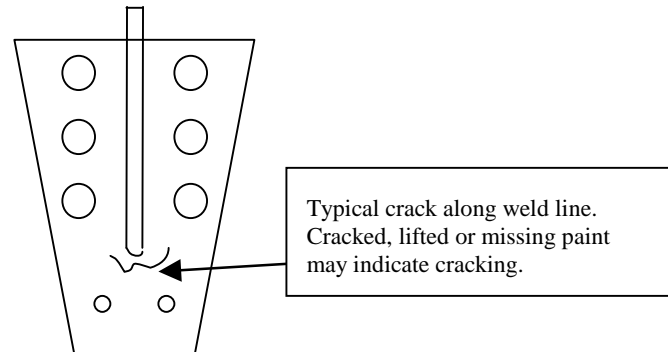
Figure 1: Inspection Location

1. Visually inspect the gusset weld area for cracks. See figure 1 for the typical crack location. If there is any cracked, lifted or missing paint in the area of the weld, or a crack is suspected, then perform a further detailed inspection in accordance with requirement 2.
2.
 - (a) Remove paint in the weld area shown in figure 1.
 - (b) Visually inspect the weld area for cracks using a bright light and magnifying glass.
 - (c) If doubt still exists as to whether a crack is present, confirm using Fluorescent Penetrant Inspection (FPI).
 - (d) If the bracket is cracked, repair or replace the cracked bracket. Any repairs must be in accordance with manufacturer's instructions or a repair scheme approved by a CAR 35 Authorised Person.

Background: A defect was reported where an inner flap attachment bracket was found cracked along the gusset weld line. Failure of this bracket may result in asymmetric flap deployment and/or inability to lower or raise the flaps. A failure of this type would most probably result in loss of control, with catastrophic consequences.

Embodiment of Eagle Aircraft (M) Sdn. Bhd. Service Bulletin 1120 Original or later approved issue is terminating action for the requirements of this AD.
