**AIRWORTHINESS DIRECTIVE**

**Beechcraft 1900 Series Aeroplanes****AD/BEECH 1900/41****Elevator Trim System****13/2003  
DM**

**Applicability:** All Models 1900, 1900C, and 1900D aircraft.

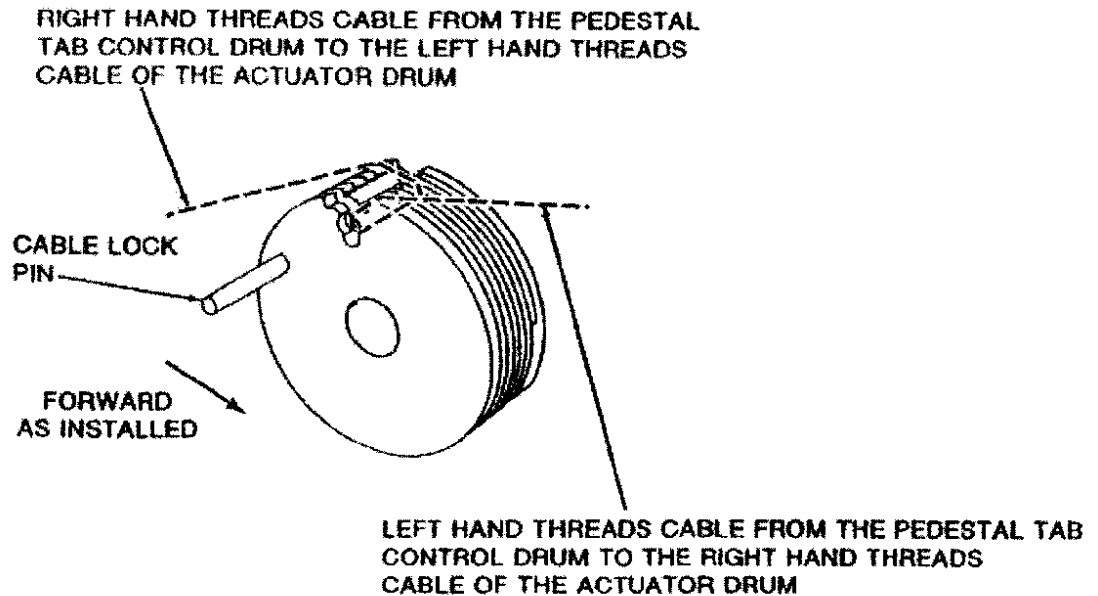
Figure 1

- Requirement:**
1. Mark with a pen, the applicable figure in the maintenance manual as referenced below. The depiction in the referenced figures is incorrect for the elevator trim drum only, and depicts the cable drum at 180 degrees from the installed position and shows the open, keyed side of the drum instead of the flat side of the drum. Insert corrected figure (Figure 1 of this Directive) into the applicable maintenance manual, and identify it accordingly, as specified in Raytheon Safety Communique No. 234, dated September 2003:

Background: The FAA issued AD 2003-20-10 as a result of an analysis of the maintenance procedures of the elevator trim system. The actions required by this Directive are to detect and correct any maintenance-induced problems with the elevator trim system installation before problems occur during operation. Such a condition could lead to difficulties in controlling the aircraft or a total loss of pitch control.

- a. Figure 9 of Chapter 27-10-00 of the Model 1900/1900C Airliner Maintenance Manual (114-590021-7B). Clearly note in pen that existing portion of Figure 9 is correct for the aileron trim drum only and insert corrected figure (Figure 1 of this Directive) marked in pen as correct for the elevator trim drum only; or,

- b. Mark out Figure 201 of Chapter 27-30-04 of the Model 1900D Airliner Maintenance Manual 125-590000-15). Insert corrected figure (Figure 1 of this Directive).
