**AIRWORTHINESS DIRECTIVE**

**Beechcraft 35 (Bonanza) Series Aeroplanes****AD/BEECH 35/70**  
**Amdt 1****Airspeed Restriction****1/2003**

Applicability: Models 35, A35, B35, and 35R aircraft, all serial numbers.

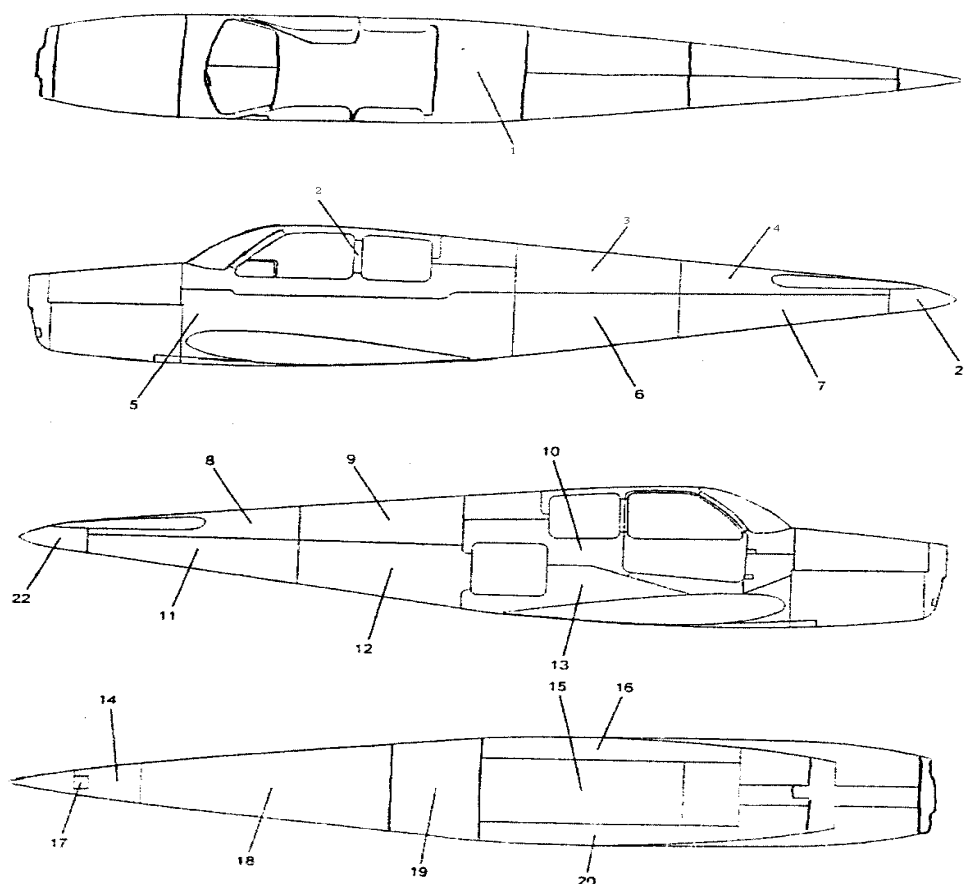
Figure 1

- a. Part of this is an inspection of the aft fuselage skin for wrinkles or cracks. Specific skin thicknesses are presented in Figures 1 and 2 of this Directive. The skin thickness measurement is not repetitive.
