# COMMONWEALTH OF AUSTRALIA CIVIL AVIATION SAFETY AUTHORITY SCHEDULE OF AIRWORTHINESS DIRECTIVES

#### McDonnell Douglas (Hughes) and Kawasaki 369 Series Helicopters

AD/HU 369/111	Tail Rotor Blade Pitch Horn	6/2003 TX

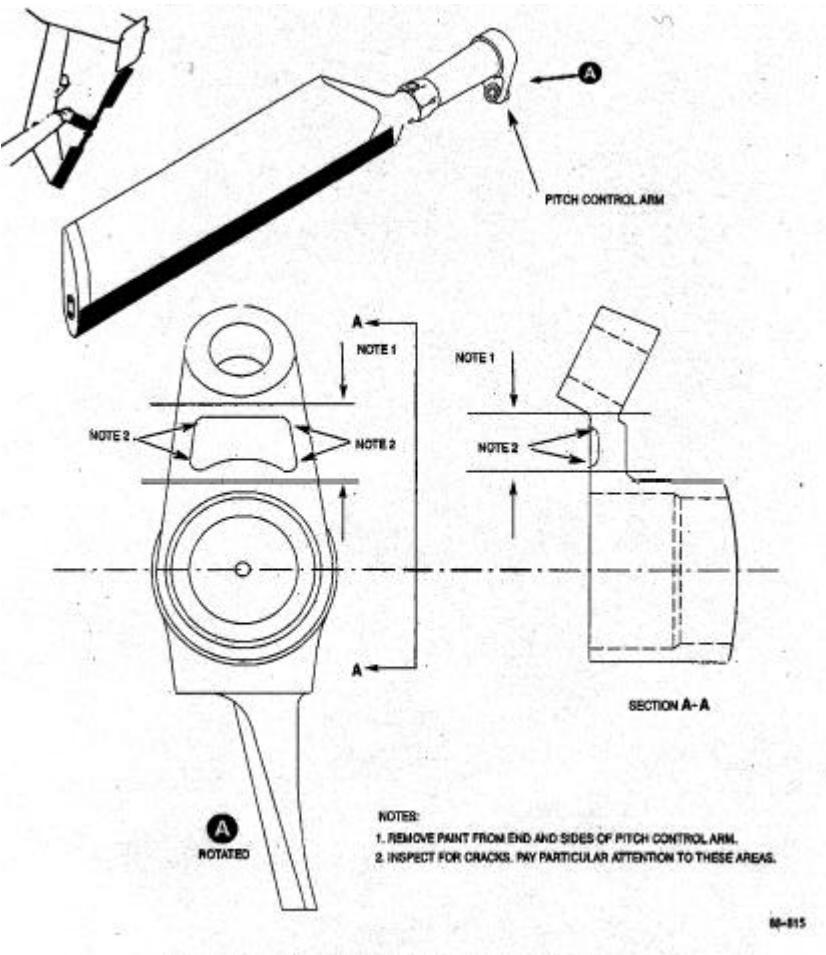
Figure 1. Tail Rotor Blade Assembly Inspection

- Requirement: 1. Perform a one-time visual inspection of each tail rotor blade pitch horn for a crack or corrosion in the area indicated by Note 2 in Figure 1 of this Directive. Paint removal in accordance with Note 1 of Figure 1 of this Directive is not required for the visual inspection.
  - 2. This Directive establishes a new retirement life of 400 hours time in service for affected tail rotor blades. For helicopters with an affected tail rotor blade installed that has between 390 and 700 hours time in service, remove and replace the tail rotor blade with a serviceable blade.
  - 3. Revise the helicopter Airworthiness Limitations section of the maintenance manual to indicate the new retirement for affected tail rotor blades.

Background: The FAA received two reports of cracked tail rotor blade pitch horns that failed during flight. In both occurrences, the pilot was able to land the helicopter without further incident. Investigation revealed that the cause of the failures was a fatigue crack in the pitch horns that developed before the tail rotor blade reached its retirement life.

For helicopters with a tail rotor blade installed that has more than 700 hours time in service, a one-time special flight permit to fly to a repair facility may be issued only upon completion of an eddy current surface scan of each affected pitch horn (refer Figure 1). Paint removal in accordance with Note 1 of Figure 1 of this Directive is required for the surface scan. If a crack is found, before further flight, replace the cracked tail rotor blade with a serviceable blade.
