[Docket No. FAA-2010-1013; Directorate Identifier 2010-CE-048-AD; Amendment 39-16478; AD 2010-21-18]

Airworthiness Directives; Cessna Aircraft Company (Cessna) Models 336, 337, 337A (USAF 02B), 337B, M337B (USAF 02A), T337B, 337C, T337C, 337D, T337D, 337E, T337E, 337F, T337F, 337G, T337G, 337H, P337H, T337H, T337H-SP, F337E, FT337E, F337F, FT337F, F337G, FT337GP, F337H, and FT337HP Airplanes

2010-21-18 Cessna Aircraft Company: Amendment 39-16478; Docket No. FAA-2010-1013; Directorate Identifier 2010-CE-048-AD.

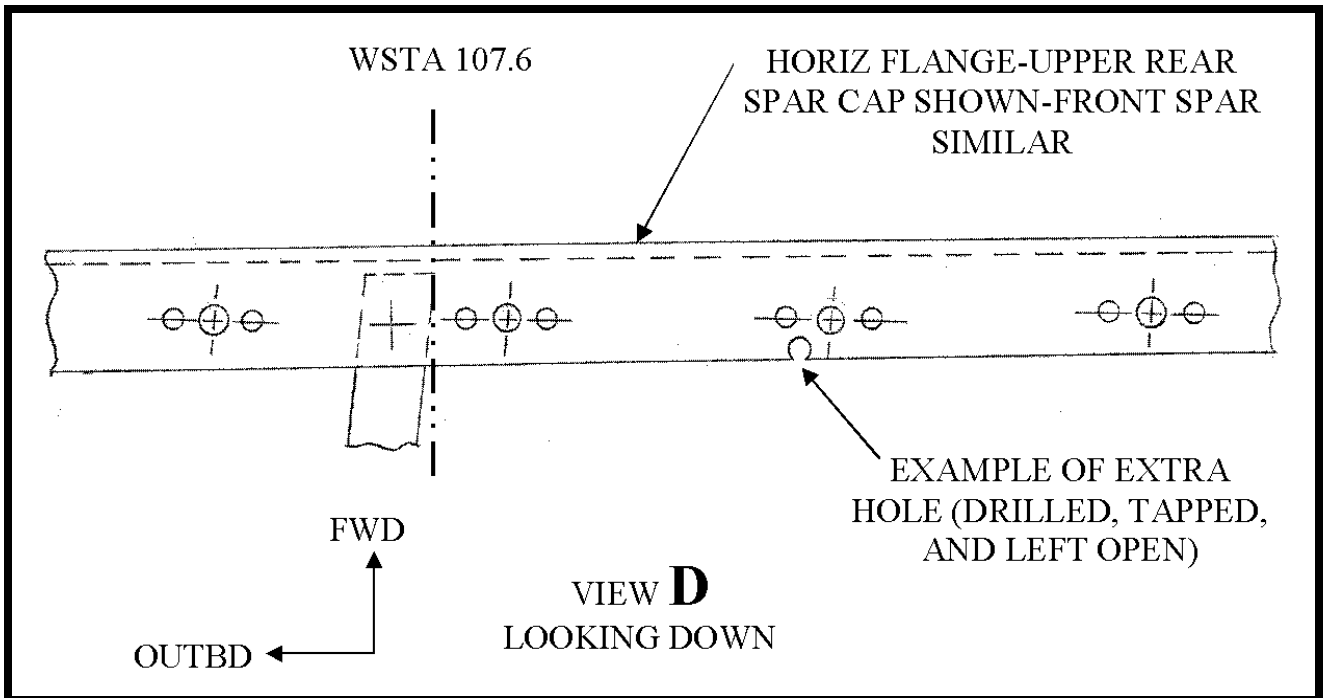
Figure 5

- (2) Inspect wing skins for unreinforced cutouts. (See View C, Figure 4).
- (3) Inspect the upper spar cap horizontal flanges for open holes (See View D, Figure 5).
