**AD/PMC/35
Amdt 1**

**Propeller Blade Butt Retention
Thread - Eddy Current Inspection**

NDT PROCEDURE: McCauley Propeller Blade Butt Retention Thread

PROCEDURE NO: DOT/NDI/EC5

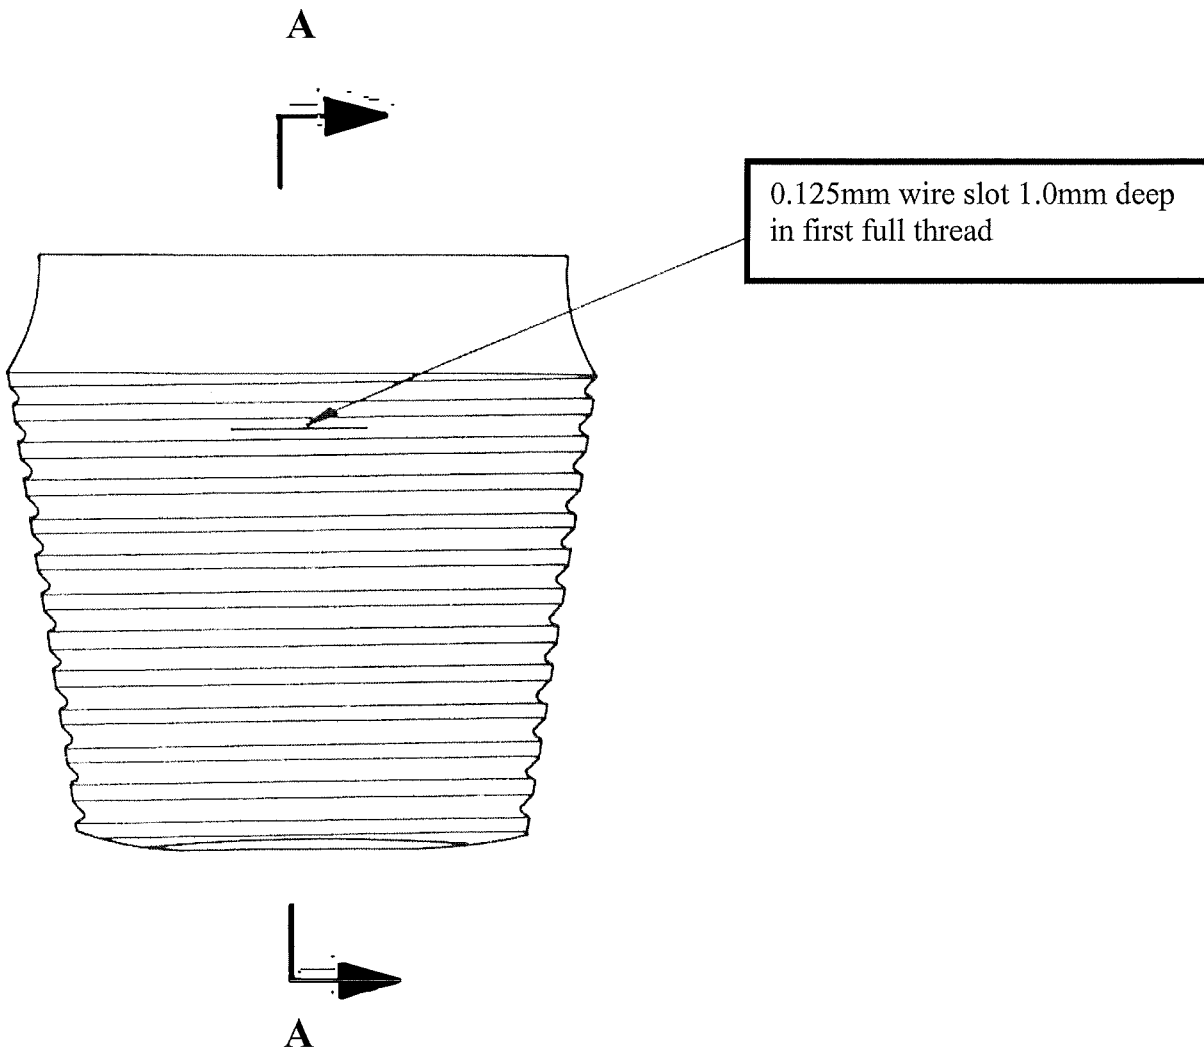
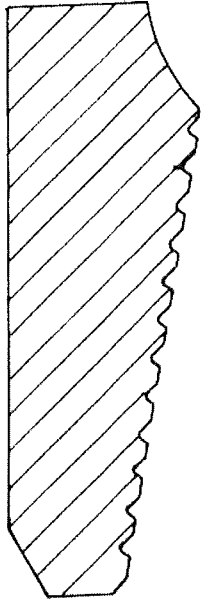
FIGURE 1

Reference Standard containing reference slot in first full thread.

5.1 A special eddy current probe shaped to fit the threads and containing a coil positioned so that its ferrite core is contiguous with the root of the thread as shown in Figure 1.

6.1 A calibration standard shall be manufactured in accordance with the requirements of Figure 1.
